## MEMORANDUM

SUBJECT: Site Assessment: Certain-Teed Transite Pipe  
A.K.A Maline Creek, 600 St. Cyr Road, St. Louis, Missouri  
TDD#: T07-9203-012  
PAN#: EM00307SAA  
EPA/OSC: Mark Roberts

SITE MAP

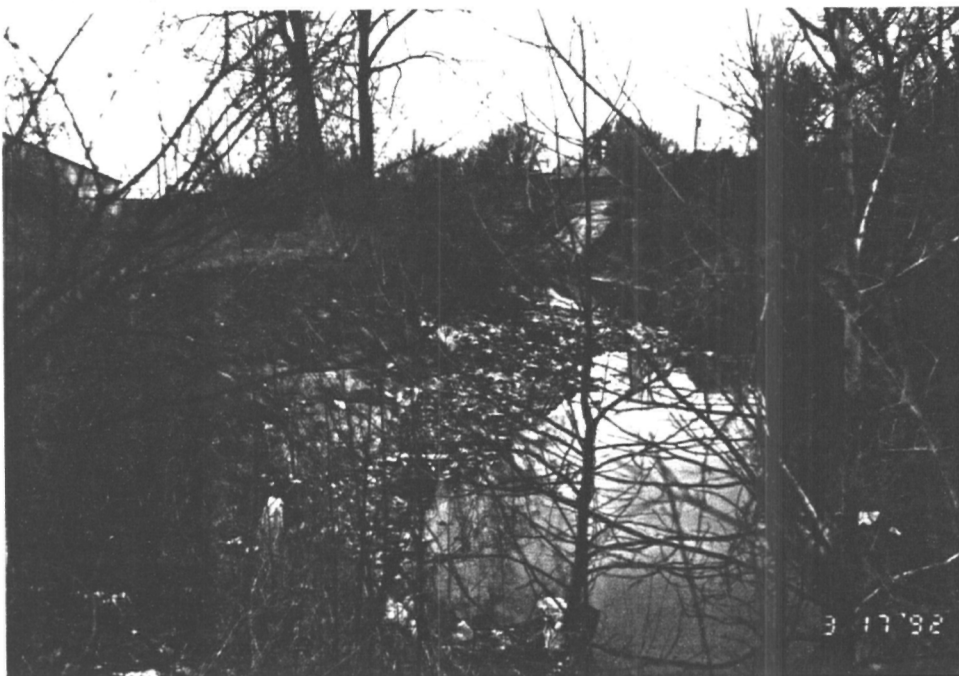
Photographer: Joe Parish  
Date/Time : 3/17/92/1215  
Lens: Type: 50mm/normal  
Serial No.: 1063023  
Frame No. : 1  
Direction : E  
Comments :  
South of former GAF, north  
bank of creek

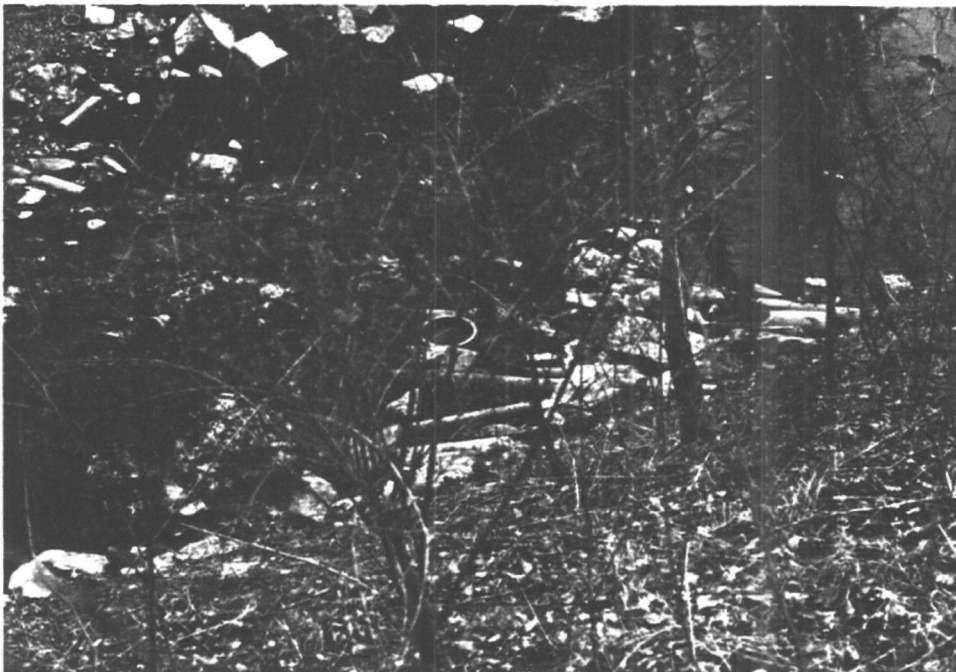
Photographer: Joe Parish  
Date/Time : 3/17/92/1217  
Lens: Type: 50mm/normal  
Serial No.: 1063023  
Frame No. : 2  
Direction : S  
Comments :  
North edge of creek, SW of  
Certain-Teed

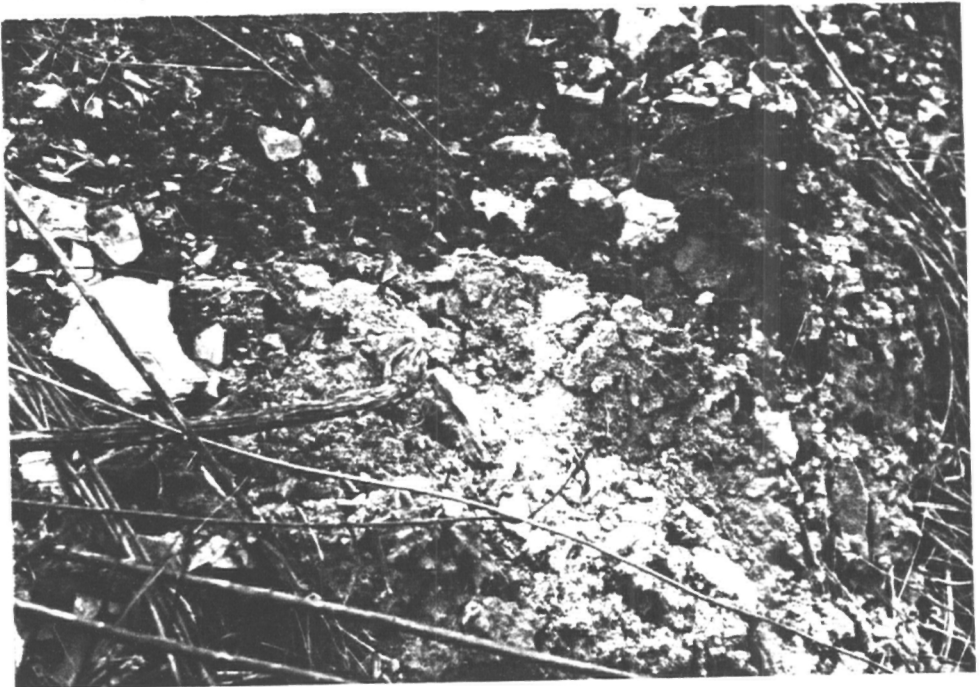
to be sheeting was visible in the rip-rap area. What appeared to be insulation material had been exposed by erosion at the upper bank of the creek. Both this material and the sheeting were sampled (sample numbers 005 and 006, see the site map for location). The insulation material was friable and particles became airborne during sample collection. The sheeting appeared hard, stable, non-friable, and was sparsely scattered throughout the rip-rap.

Photographer: Joe Parish  
Date/Time : 3/17/92/1220  
Lens: Type: 50mm/normal  
Serial No.: 1063023  
Frame No. : 3  
Direction : SE  
Comments :  
North bank, apparent  
insulation, sample 5 location

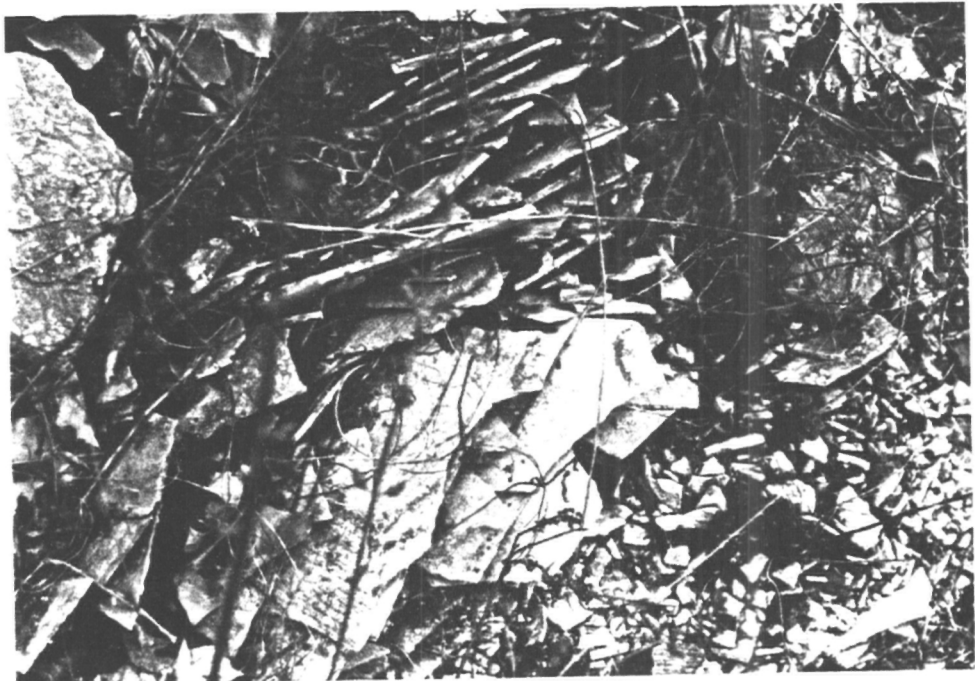
Photographer: Joe Parish  
Date/Time : 3/17/92/1230  
Lens: Type: 50mm/normal  
Serial No.: 1063023  
Frame No. : 4  
Direction : SE  
Comments :  
North bank, sample 6 location

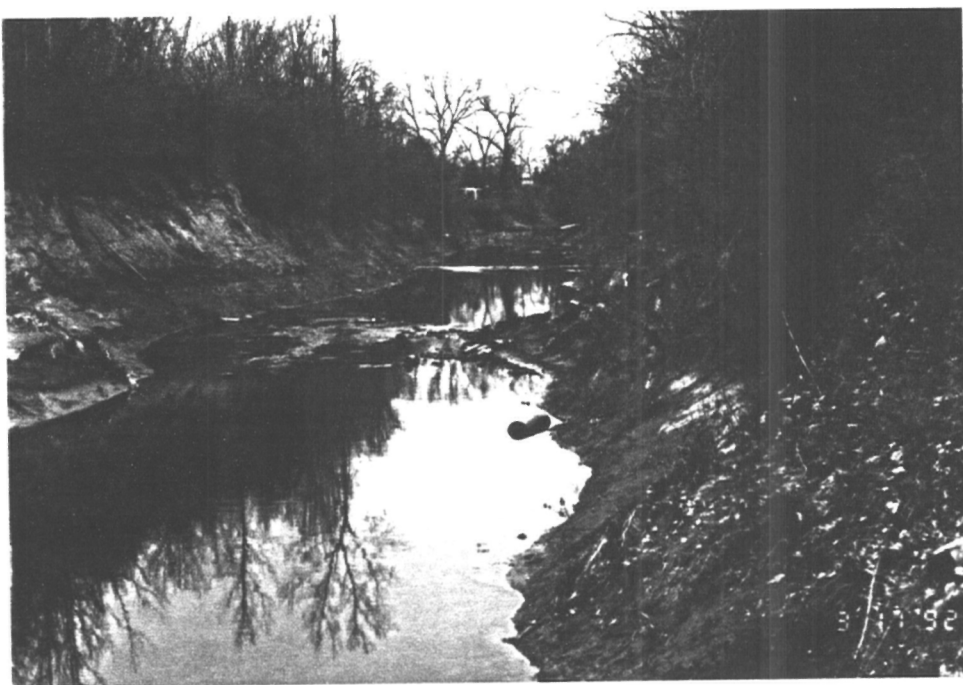
Next, TAT walked along the upper and lower banks of Maline Creek. TAT observed large quantities of transite pipe scrap material scattered down to the creek bed and extending downstream to approximately the neighboring property boundary. The upper bank of the creek appeared to be eroding, exposing more transite pipe scrap. The scrap material appeared to derive from a berm built up along the edge of the upper creek bank, presumably to cover the transite scrap. Sample number 003 was taken at this location (see site map). Transite pipe was scattered on both the near and far banks of the creek, as well as in the creek bed. A composite sample (number 004) was collected from material at these locations. The transite scrap appeared to be in two forms - scrap of the pipe itself, and scrap of the ring connectors that joined the pipe sections. The connectors were slightly friable. The pipe scrap was very hard and could only be broken by using a sledge hammer. In either case, fibers were observed sticking out of the weathered broken edges of pipe scrap.

Photographer: Dave Kinroth  
Date/Time : 3/17/92/1240  
Lens: Type: 50mm/normal  
Serial No.: 1063023  
Frame No. : 5  
Direction : NW  
Comments :  
Transite pipe and connectors,  
north creek bank south of  
former Certain-Teed

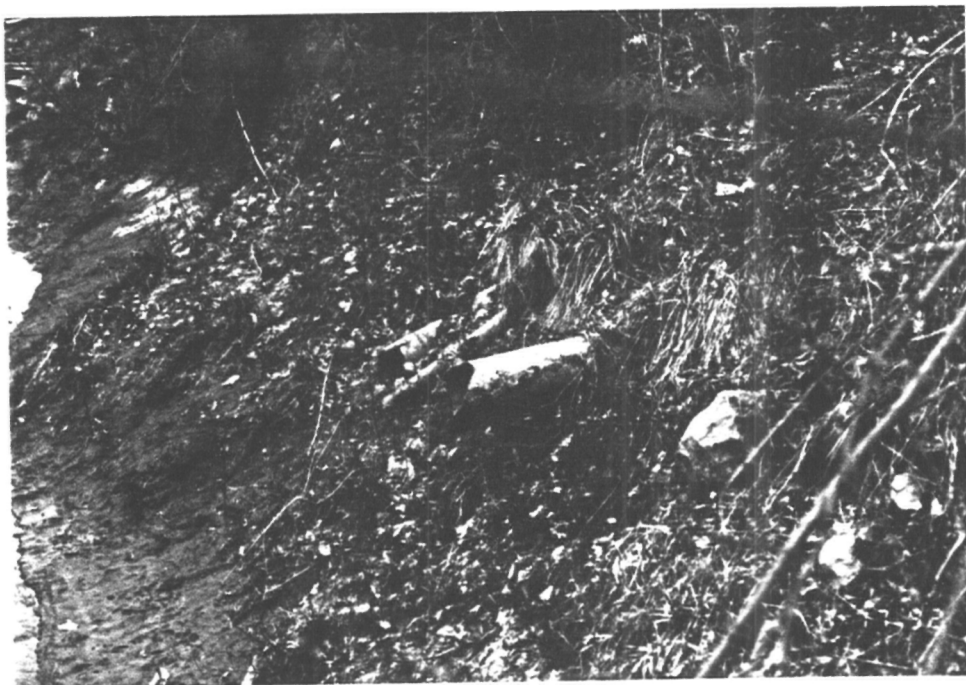
Photographer: Dave Kinroth  
Date/Time : 3/17/92/1241  
Lens: Type: 50mm/normal  
Serial No.: 1063023  
Frame No. : 6  
Direction : NW  
Comments :  
Transite pipe and connectors,  
north creek bank south of  
former Certain-Teed

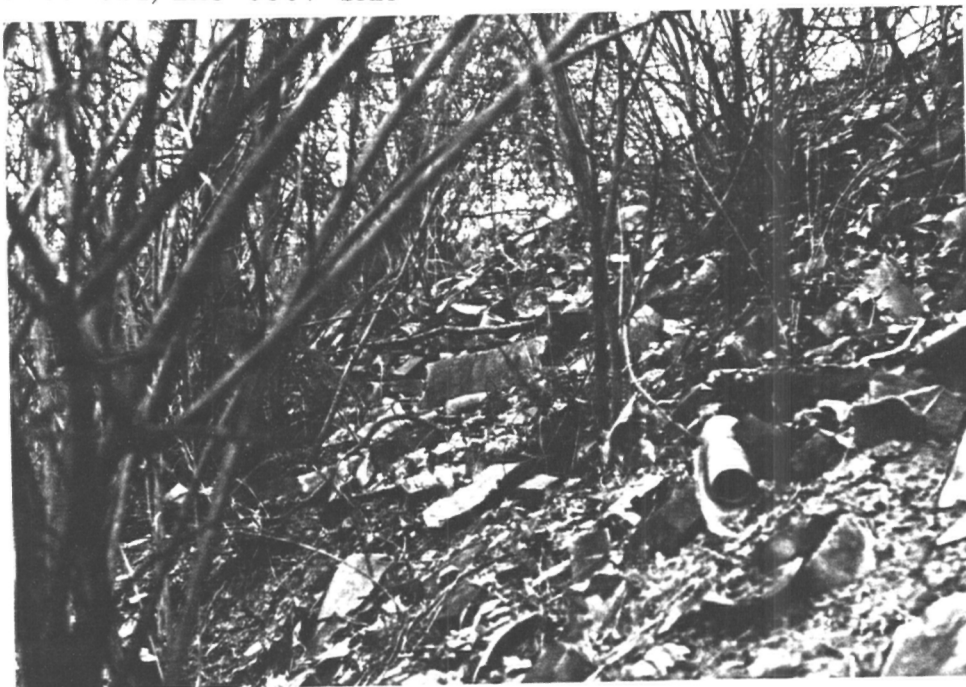
Photographer: Dave Kinroth  
Date/Time : 3/17/92/1242  
Lens: Type: 50mm/normal  
Serial No.: 1063023  
Frame No. : 7  
Direction : NW  
Comments :  
Transite pipe and connectors,  
north creek bank south of  
former Certain-Teed

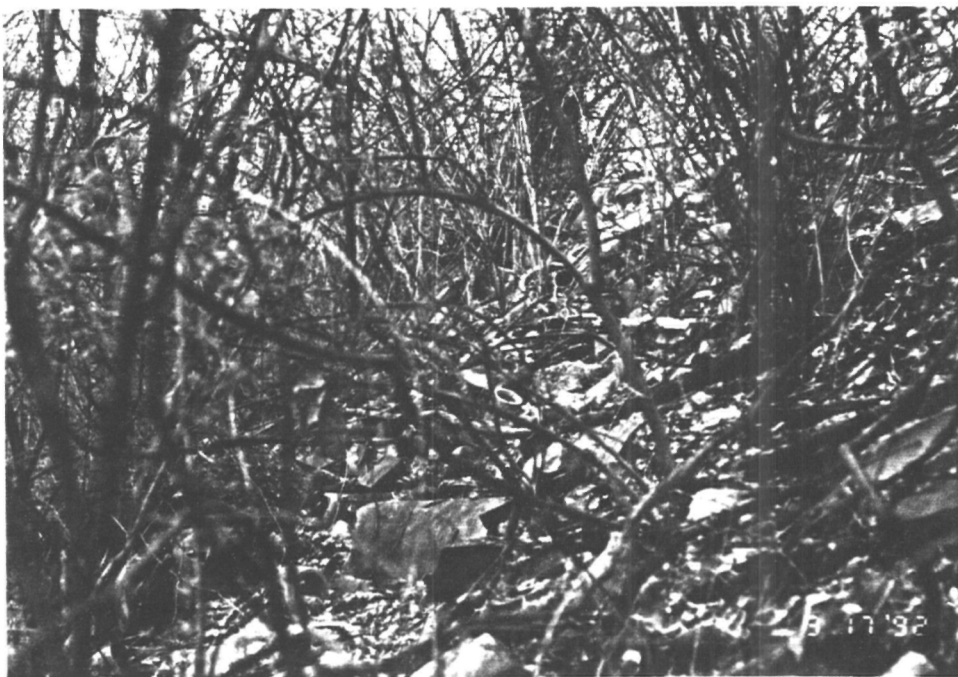
Photographer: Dave Kinroth  
Date/Time : 3/17/92/1243  
Lens: Type: 50mm/normal  
Serial No.: 1063023  
Frame No. : 8  
Direction : NW  
Comments :  
Transite pipe and connectors,  
north creek bank south of  
former Certain-Teed

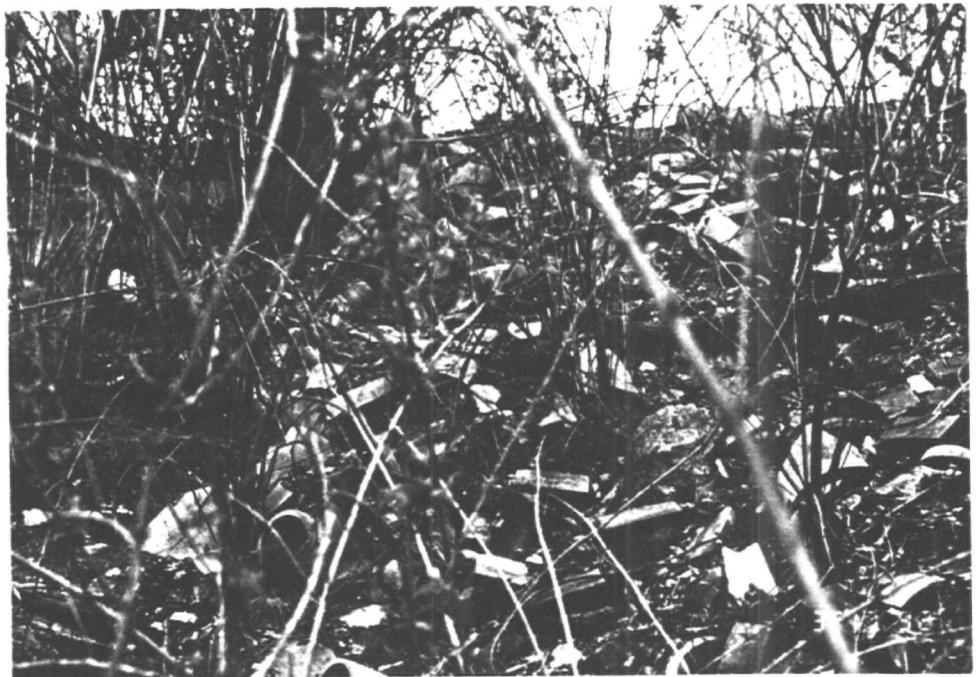
Photographer: Dave Kinroth  
Date/Time : 3/17/92/1244  
Lens: Type: 50mm/normal  
Serial No.: 1063023  
Frame No. : 10  
Direction : NW  
Comments :  
Transite pipe and connectors,  
north creek bank south of  
former Certain-Teed

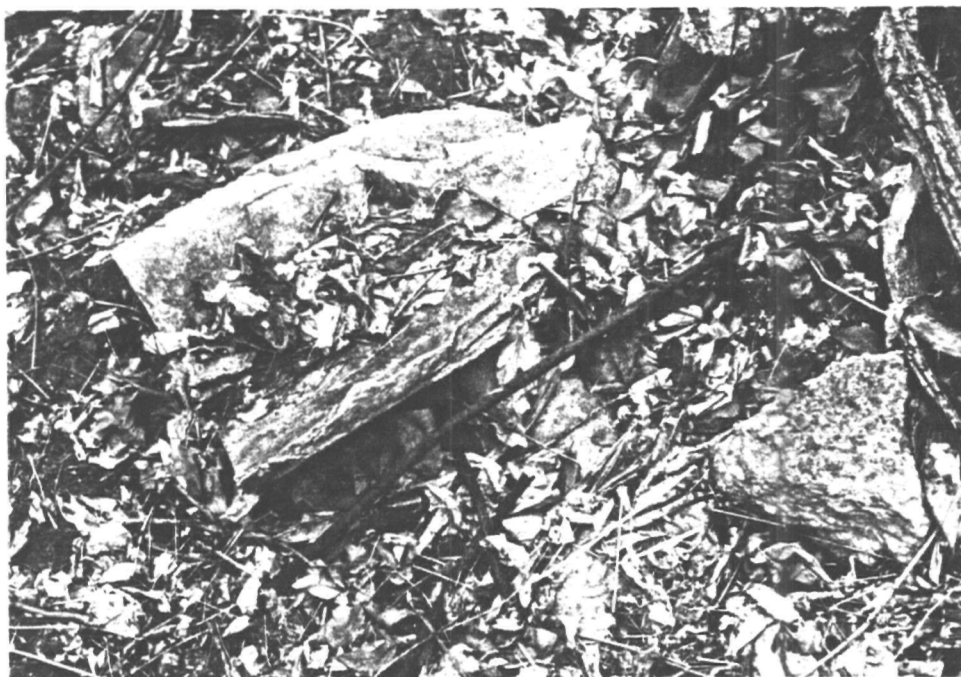
Photographer: Dave Kinroth  
Date/Time : 3/17/92/1245  
Lens: Type: 50mm/normal  
Serial No.: 1063023  
Frame No. : 11  
Direction : NW  
Comments :  
Transite pipe and connectors,  
north creek bank south of  
former Certain-Teed

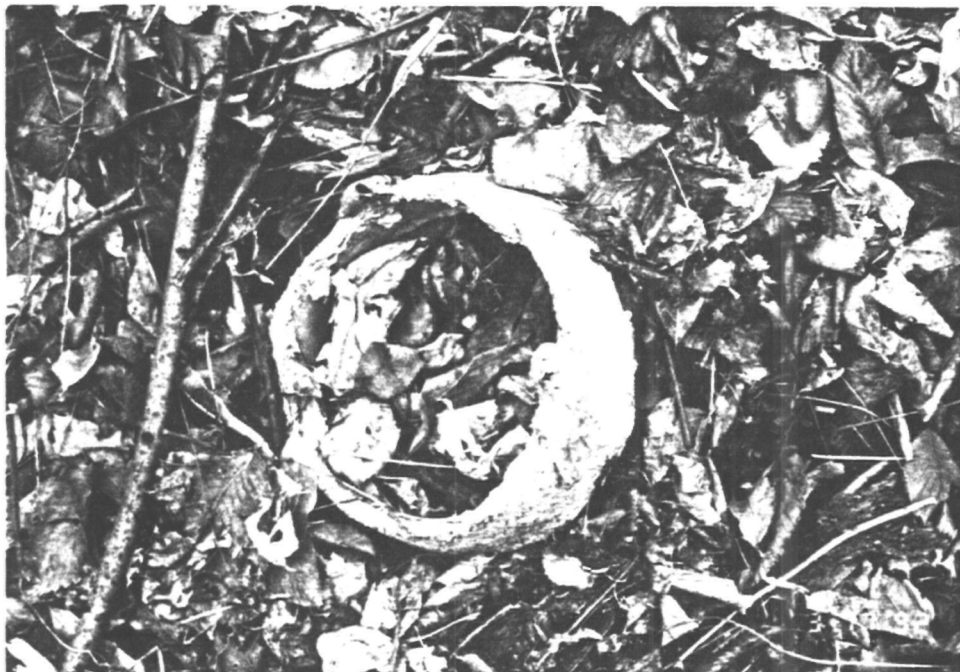
Photographer: Dave Kinroth  
Date/Time : 3/17/92/1245  
Lens: Type: 50mm/normal  
Serial No.: 1063023  
Frame No. : 12  
Direction : NW  
Comments :  
Transite pipe and connectors,  
north creek bank south of  
former Certain-Teed

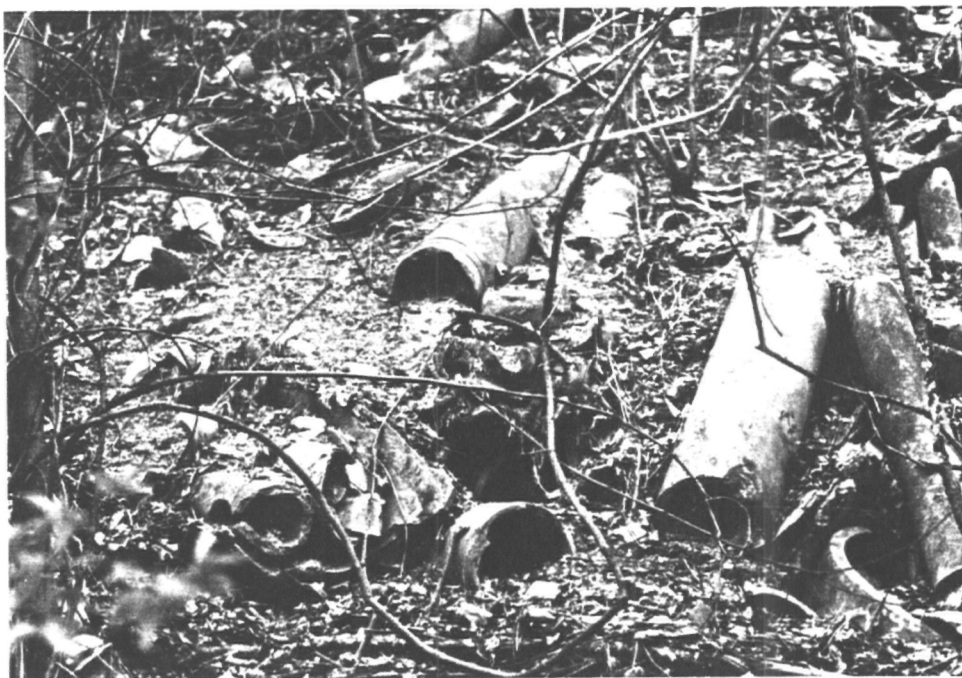
Photographer: Dave Kinroth  
Date/Time : 3/17/92/1245  
Lens: Type: 50mm/normal  
Serial No.: 1063023  
Frame No. : 13  
Direction : NW  
Comments :  
Transite pipe and connectors,  
north creek bank south of  
former Certain-Teed
